From the medieval hypogeum of Positano's Main Church to the 1st cent. BC Roman villa: archaeological excavations, restoration and musealization of the site

Diego Guarino

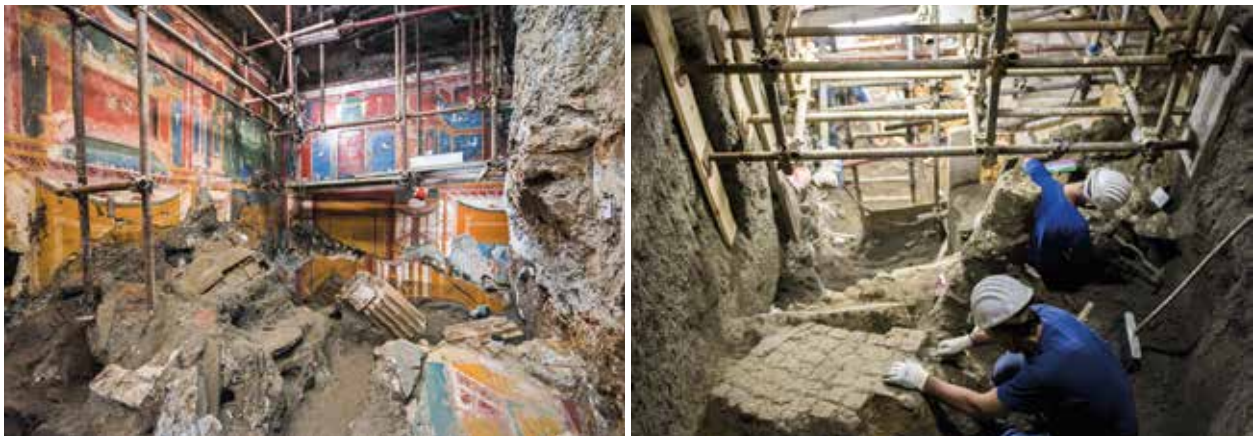
Fig. 3
Emergency
interventions made by
the restorers during
the archaeological
excavation

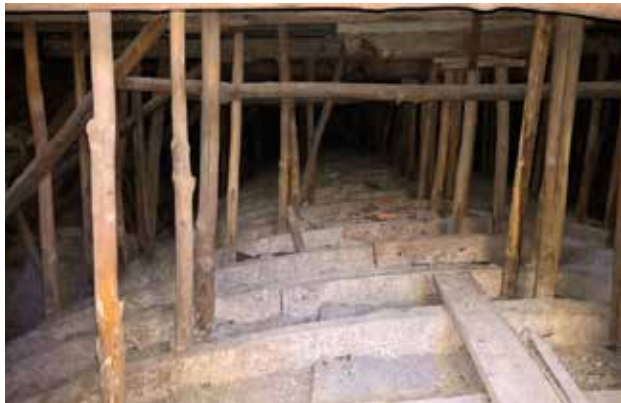
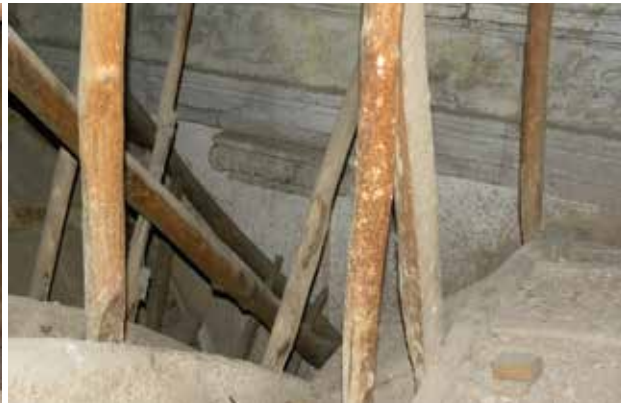
Figs. 23-25
Photos of the wooden structure of the barrel vault overlooking the central nave of the Main Church and the original tuff structure made of a strong entablature and ionic capitals.

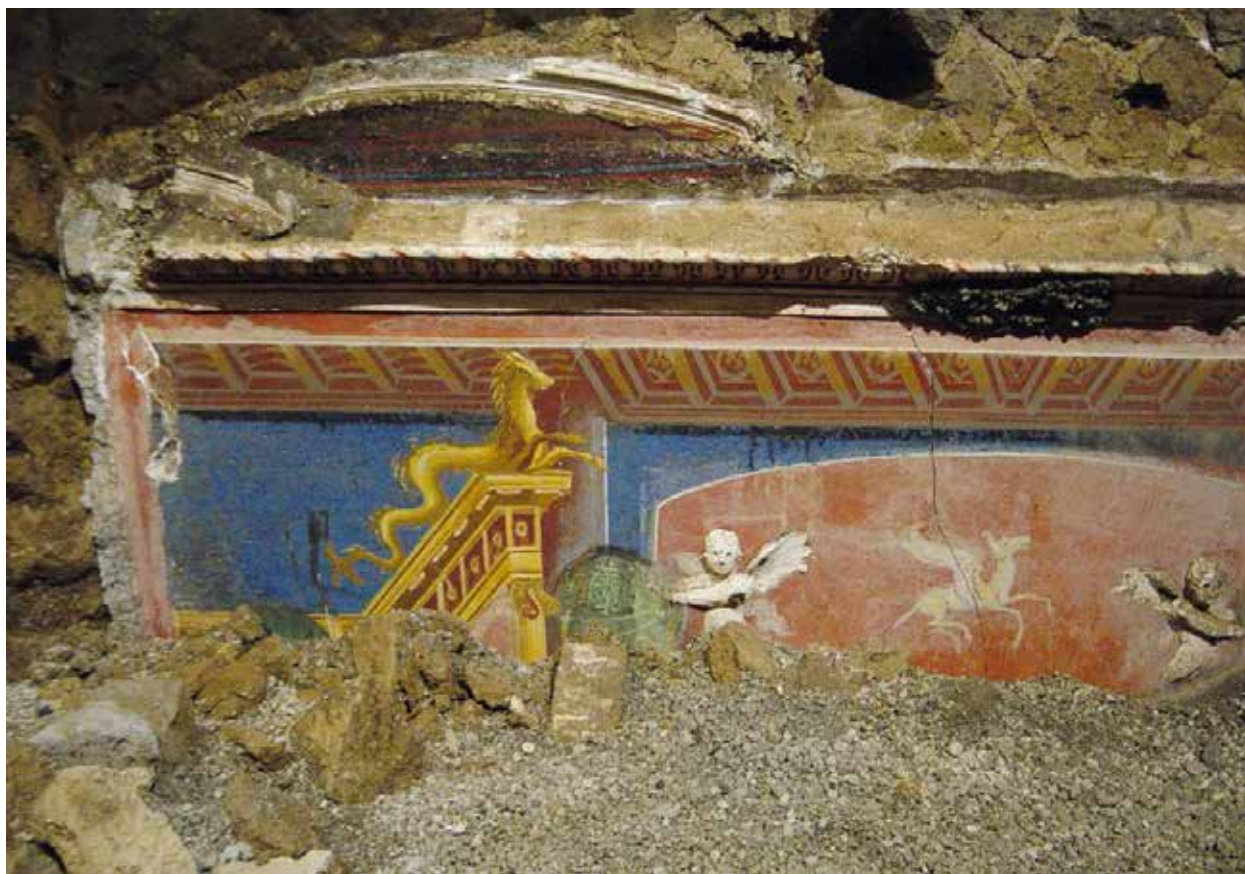
Figs. 28-29
Pyroclastic sedimentations that strongly influenced the preservation of the painted surface.

riously damaged, where a horizontal crack pattern makes the wall upper part 35 cm shifted to the south: The wall disconnection can be seen from the *triclinium* north/east corner at about 2,50m from the original mosaic walkway level through an irregular wall cut, that goes down to 1.70 m after about 4 m. Among the masonry parts that have been damaged and locked in semi-overturning condition, it is worth remembering the collapsed one at about 5 m from the mosaic *triclinium* walkway level, that stands after the frame of the north wall frescoes. These masonry sections were made safe through the armed (with stainless steel 8-16 mm bars) hydraulic lime mortar microinjections. It is necessary to state which and how many materials buried the villa and the happening chronology. The photos depicting what happened make us believe as follows: so much melted pumice (over the m^3/m^2) fell onto the villa roof that it collapsed and it was covered by a 20/30 cm thick ash, that was quickly covered in turn by flood pyroclastic mud, that filled up the empty spaces left by the structure collapse. (figs. 30-31-32). The timing and way through which the mud buried this villa part is the

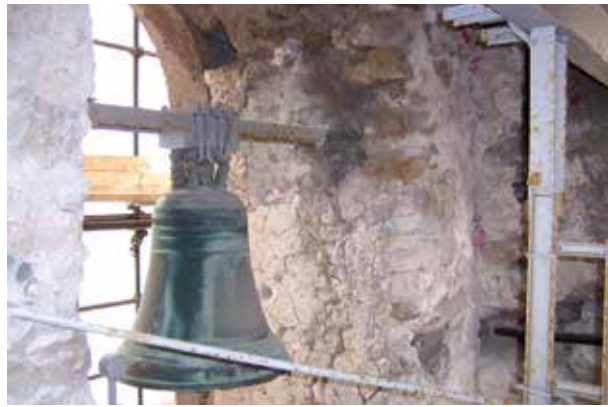
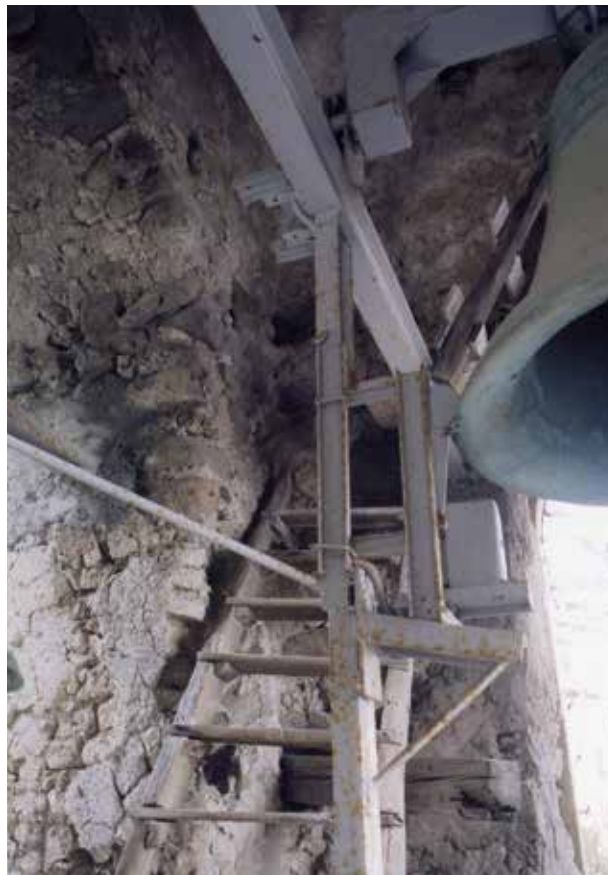
Figs. 57-58
Photo of the internal preservation state of the Bell Tower masonry structure before the 2004 consolidation works when the preservation state of the masonries, the ladder and the bell bearing structure came out.

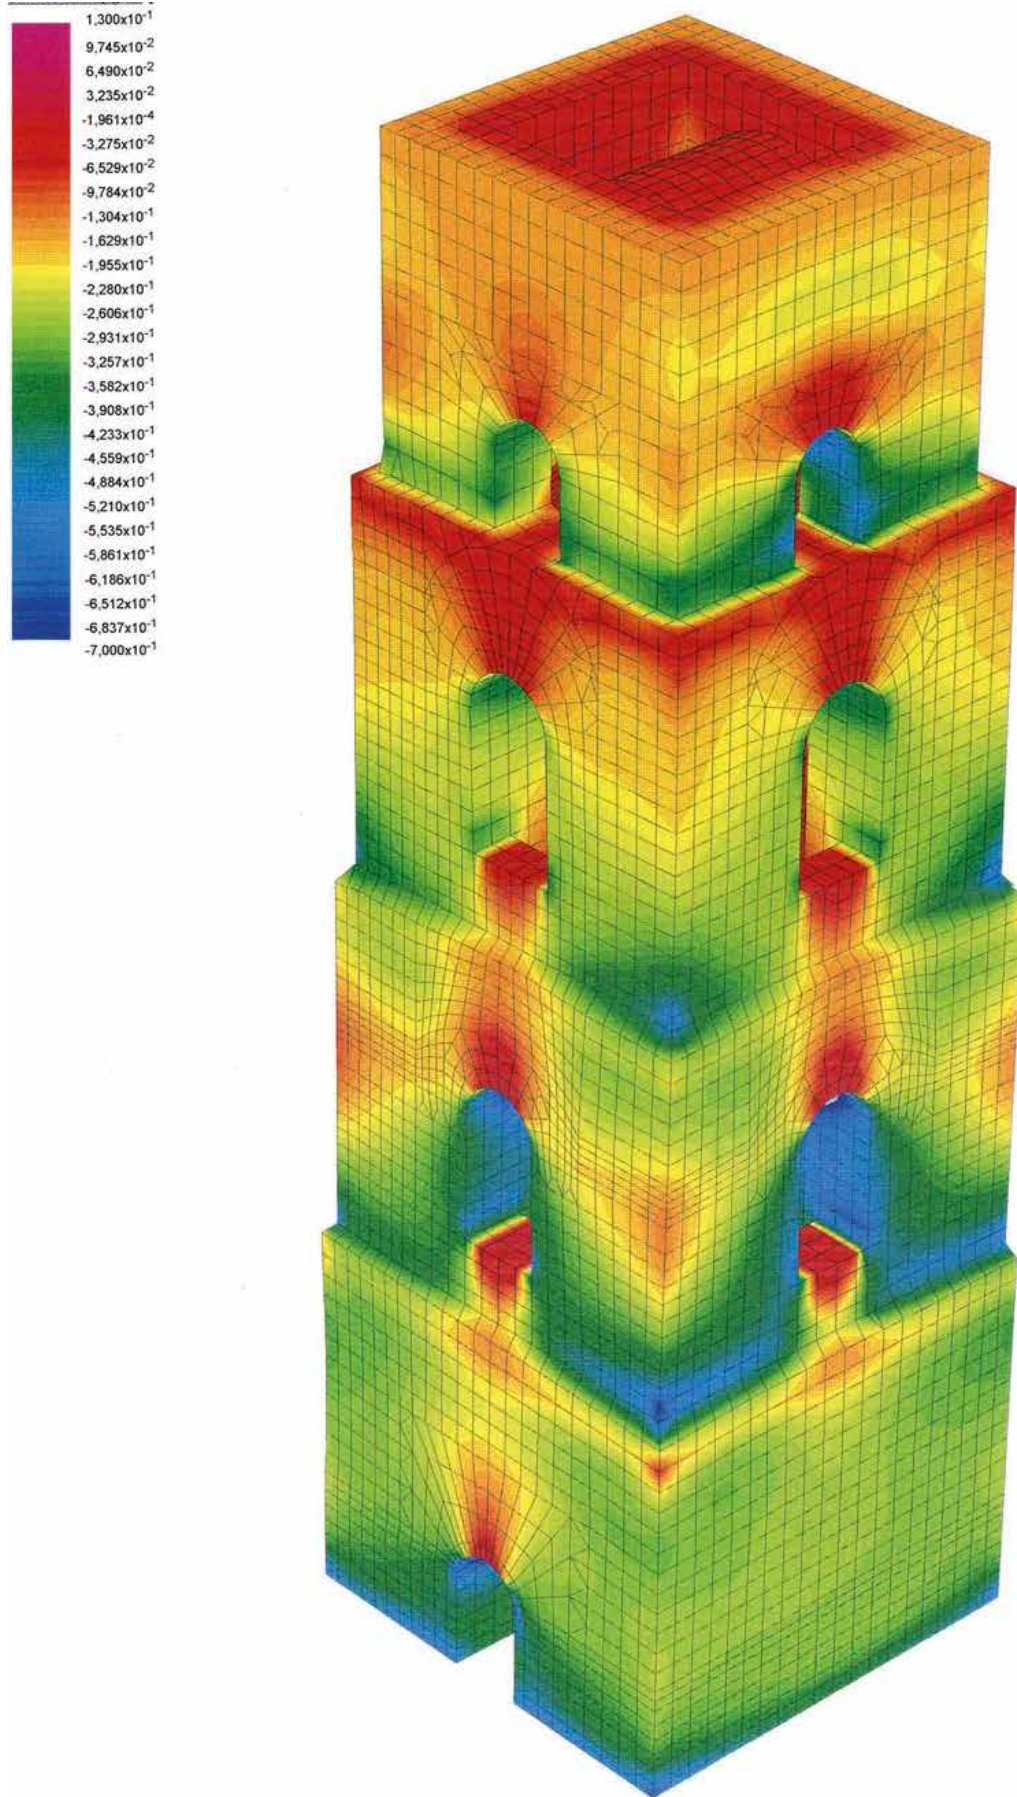
Fig. 59
Representation of the tensional stress distribution related to the minimum principal stress (the red areas represent the tensile stress) that came out from the structural analyses elaborated for the 2004 consolidation works.
