From the medieval hypogeum of Positano's Main Church to the 1st cent. BC Roman villa: archaeological excavations, restoration and musealization of the site

Diego Guarino

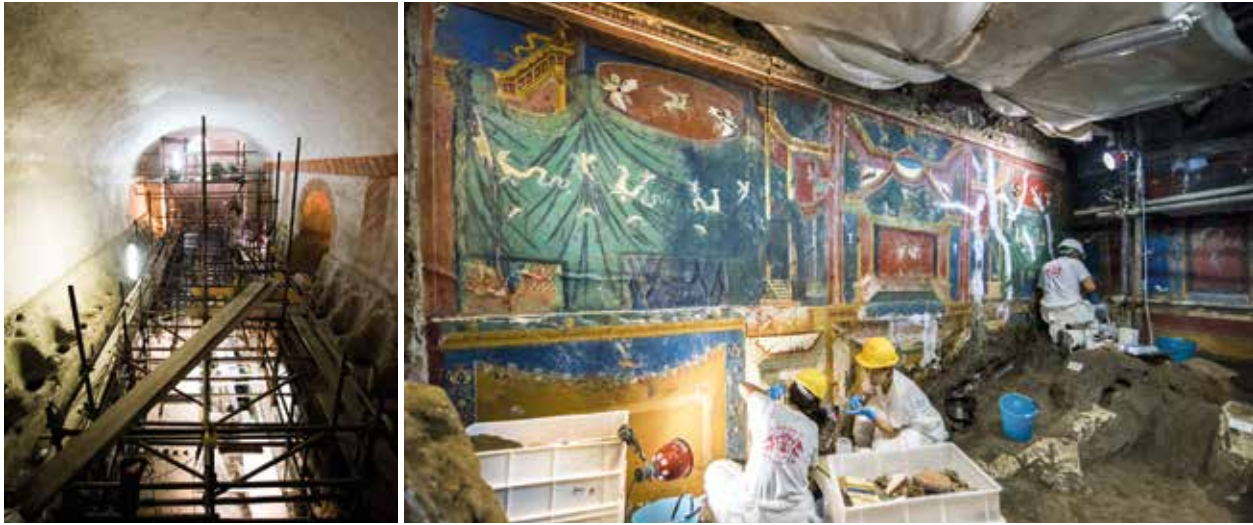
Figs. 1-2
View of the main room
Crypt where a portion of
the 1st cent. BC Roman
villa came out.

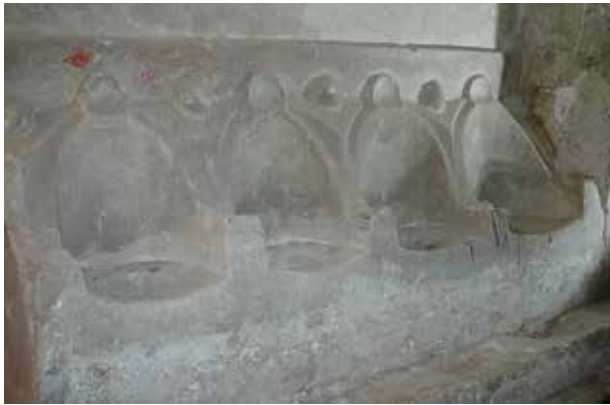
Fig. 5
Burial seats placed in the intermediate spaces between the south corridor and the big room of the upper Crypt.

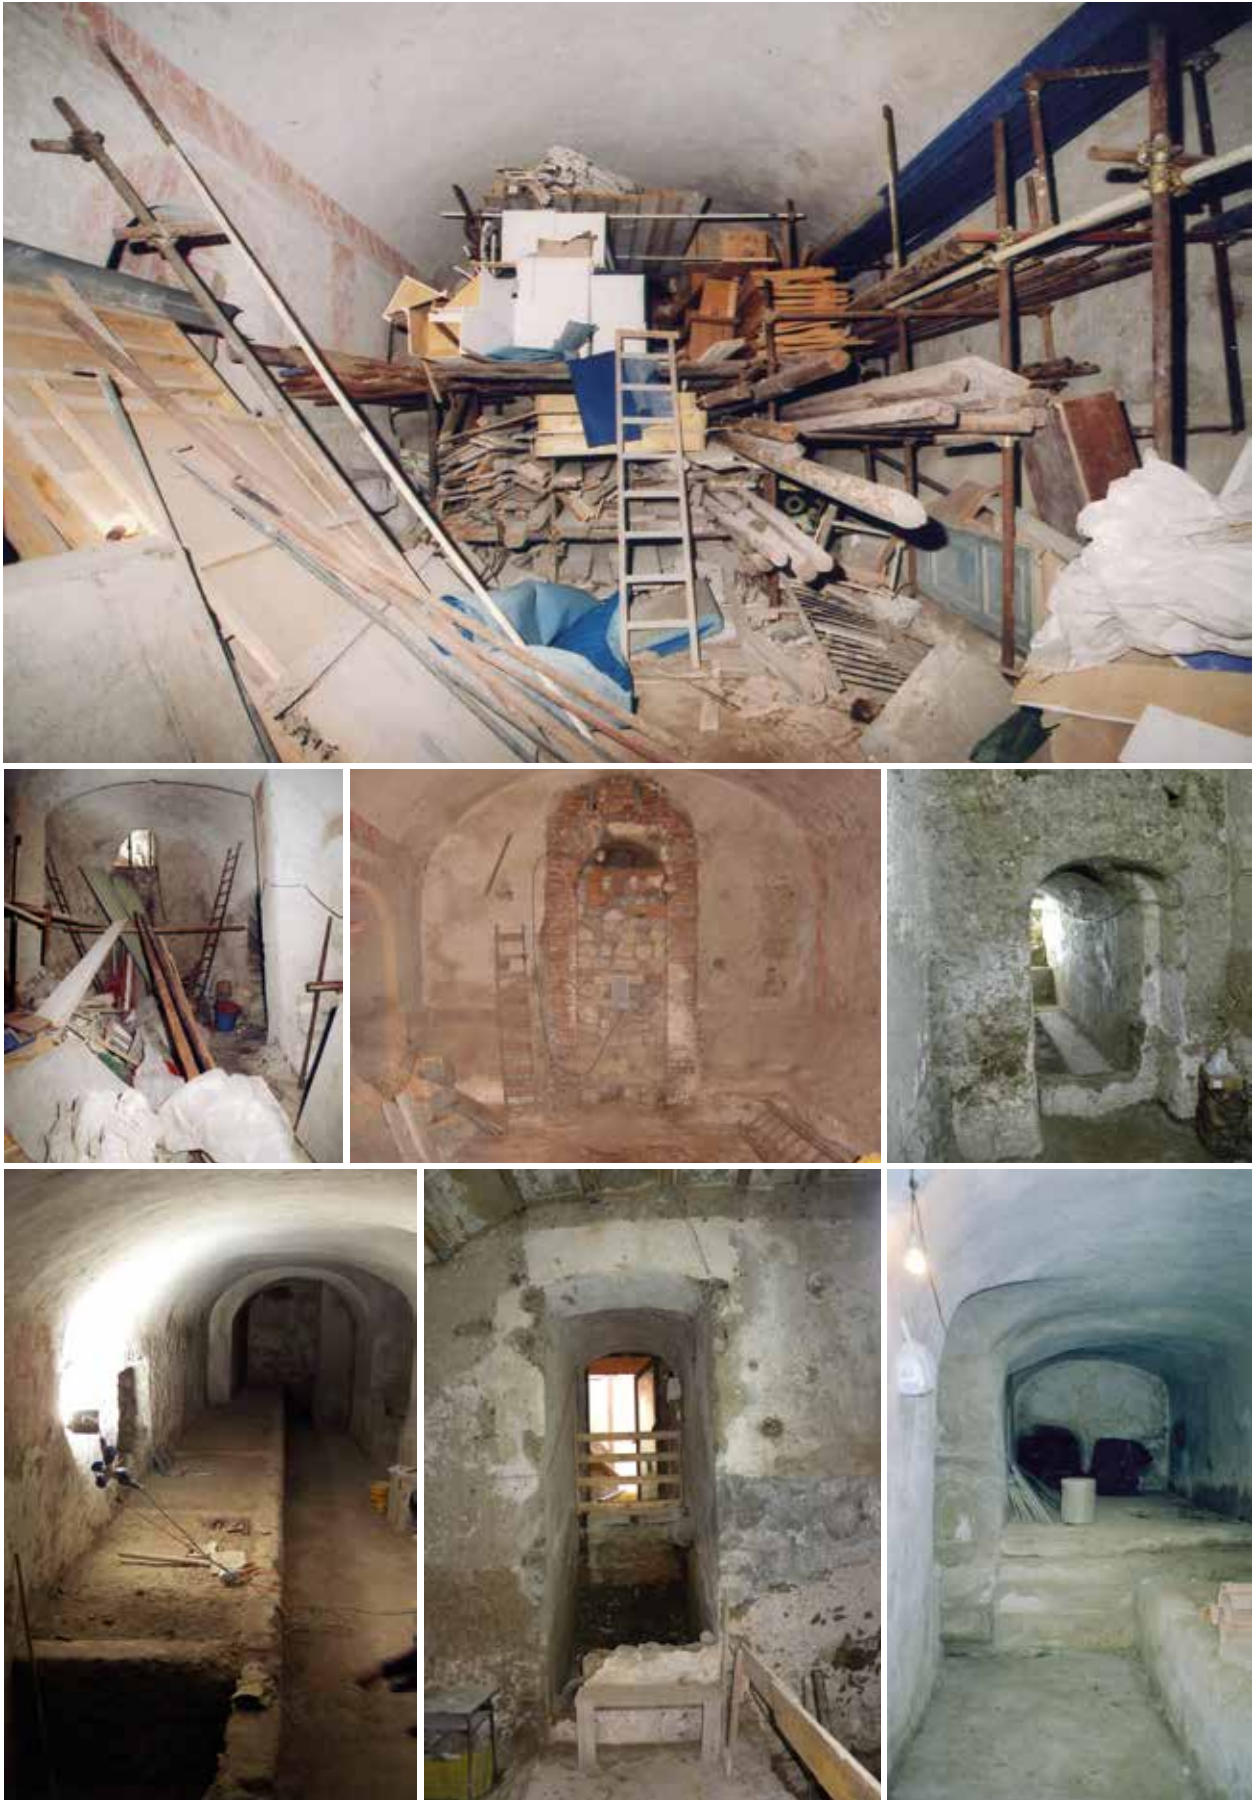
Figs. 6-12
Photos of the upper Crypt before the 2003/06 works. You can see the room conditions after the removal of the building materials showing the walled up passage to Piazza F. Gioia used as division from the Enel room still working till May 2006.

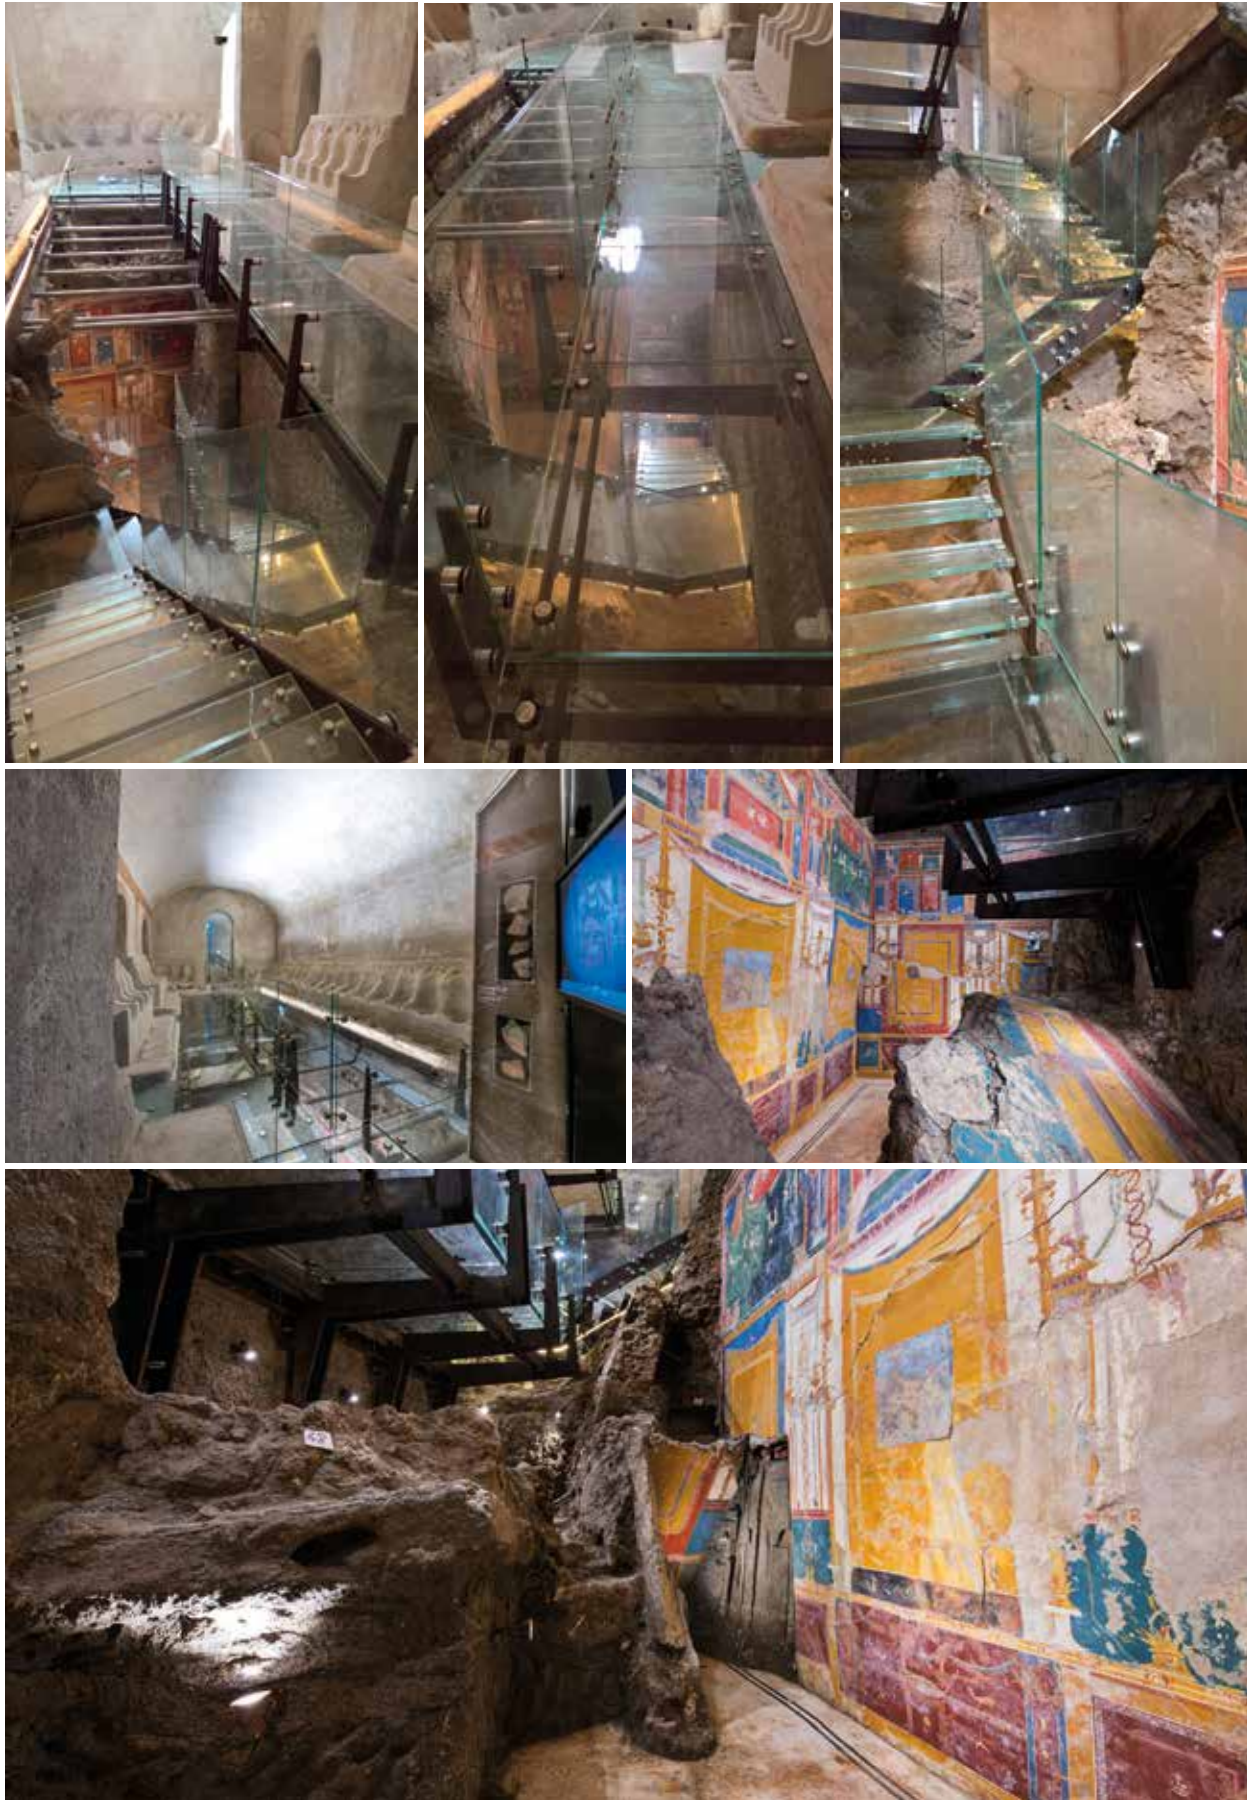
Figs. 14-19
Photos of the archaeological excavation and the corten steel and glass structures made for the museum itinerary of the area.
(Pic. 17-18-19 by Vito Fusco, Arkimedia Lab)

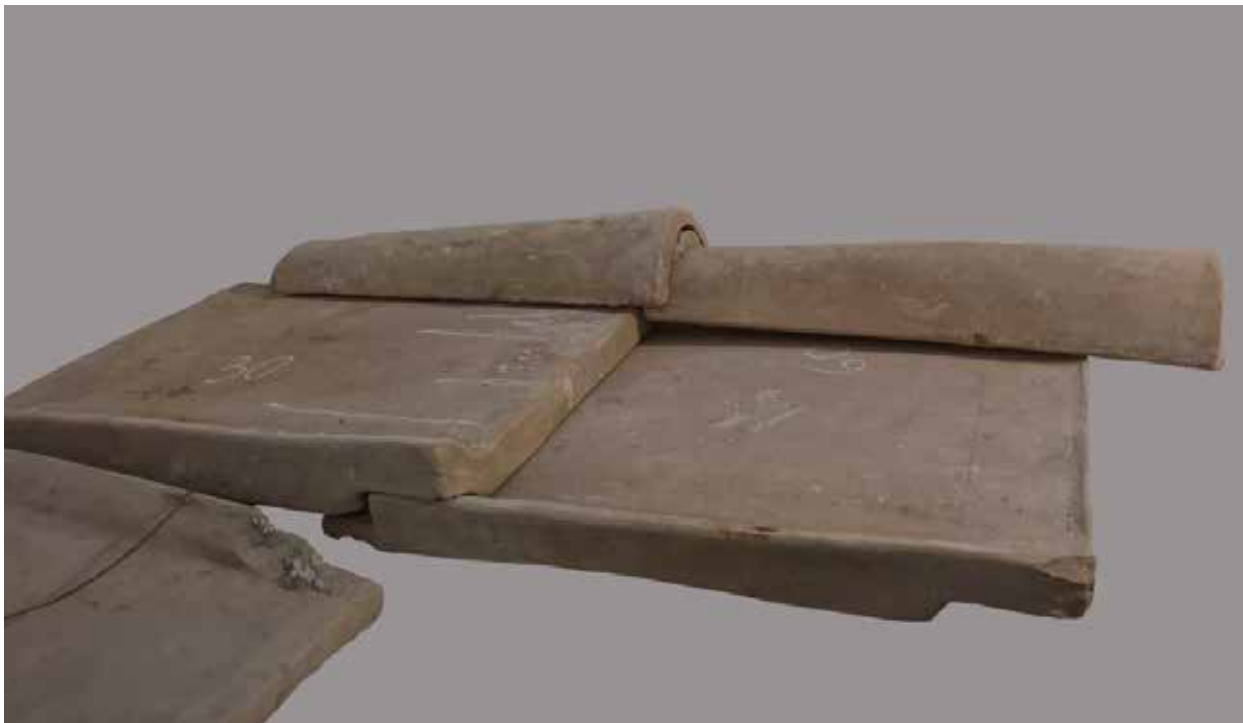
Fig. 20
Detail of the roof original recess clay-bricks of the 1st cent. BC Roman villa.

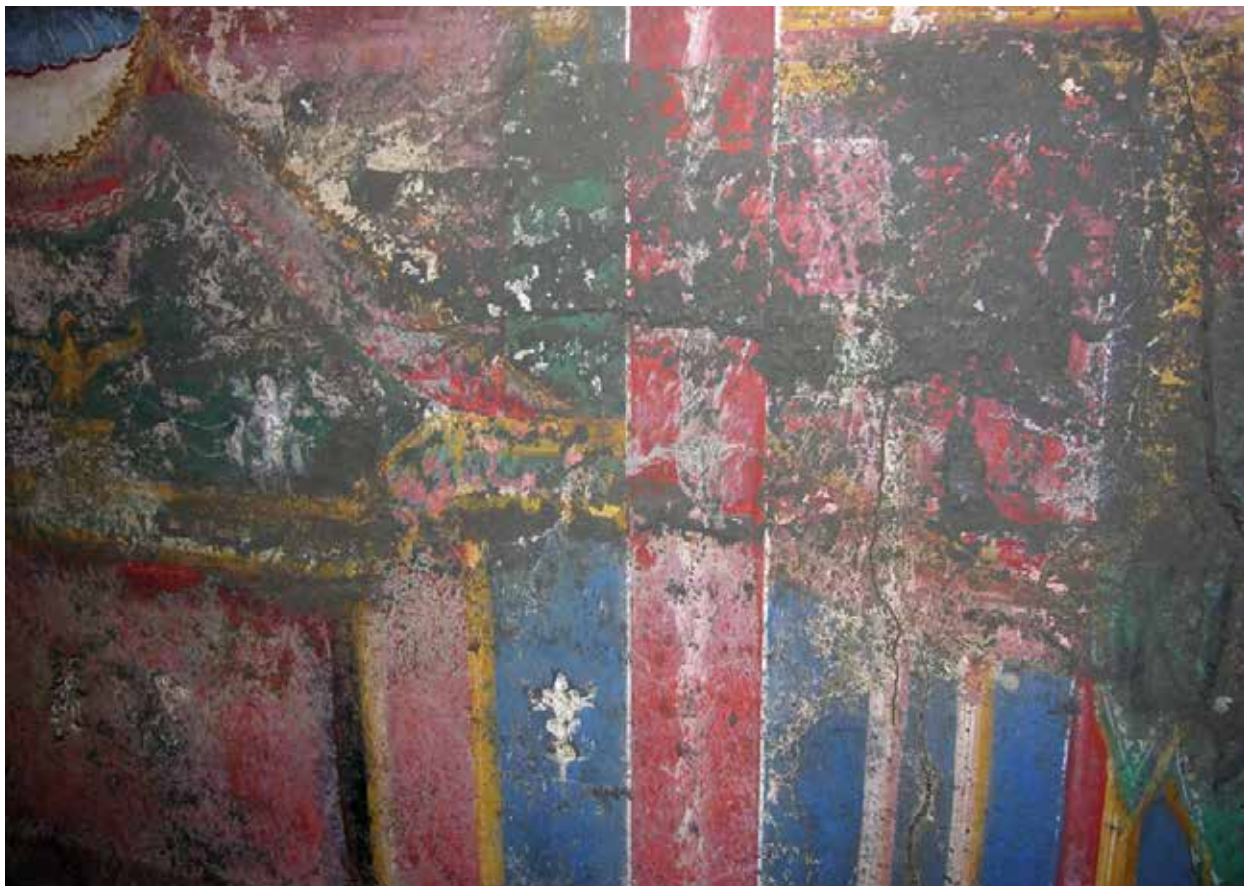
riously damaged, where a horizontal crack pattern makes the wall upper part 35 cm shifted to the south: The wall disconnection can be seen from the *triclinium* north/east corner at about 2,50m from the original mosaic walkway level through an irregular wall cut, that goes down to 1.70 m after about 4 m. Among the masonry parts that have been damaged and locked in semi-overturning condition, it is worth remembering the collapsed one at about 5 m from the mosaic *triclinium* walkway level, that stands after the frame of the north wall frescoes. These masonry sections were made safe through the armed (with stainless steel 8-16 mm bars) hydraulic lime mortar microinjections. It is necessary to state which and how many materials buried the villa and the happening chronology. The photos depicting what happened make us believe as follows: so much melted pumice (over the m^3/m^2) fell onto the villa roof that it collapsed and it was covered by a 20/30 cm thick ash, that was quickly covered in turn by flood pyroclastic mud, that filled up the empty spaces left by the structure collapse. (figs. 30-31-32). The timing and way through which the mud buried this villa part is the

Figs. 30-32
Images representing alluvial and pyroclastic deposit (melted pumice, alluvial ash and mud) that buried the 1st cent. Roman villa.

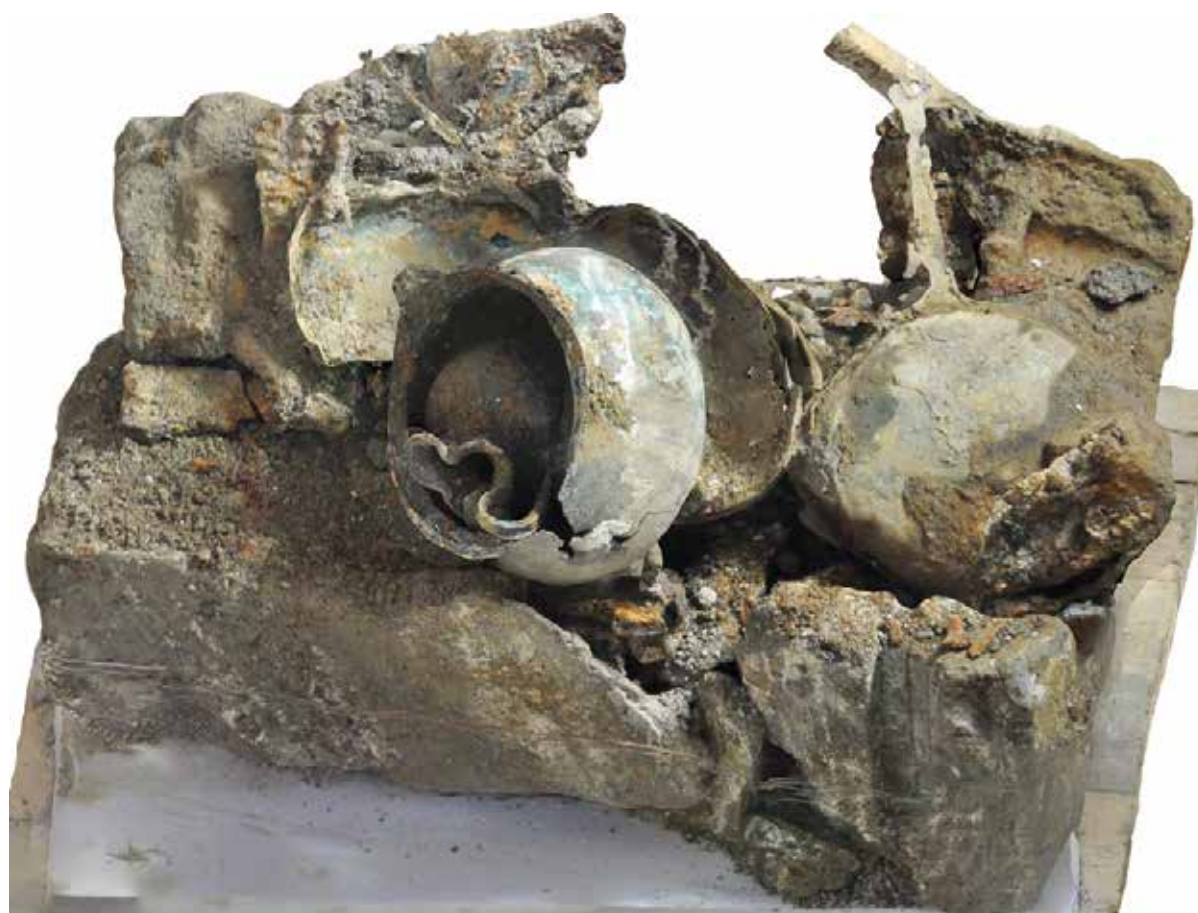
Fig. 33
3D survey of the case with objects found on the north-east corner of the triclinium during the micro-excavation made in the restoration lab.

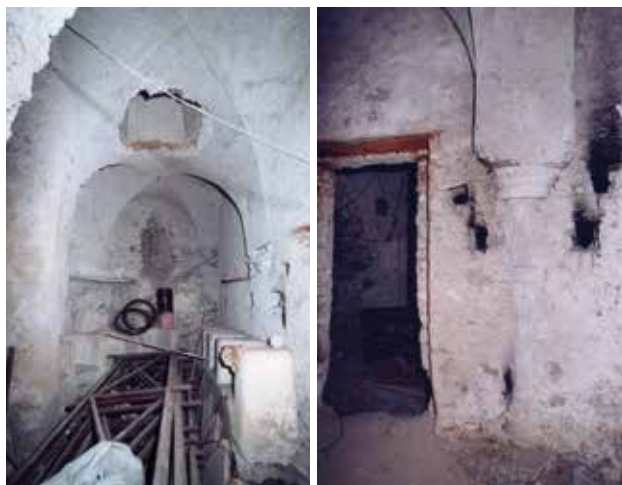
Fig. 37
Lower Crypt- detail of a
medieval column model
decorating the medieval
hypogeum originally.

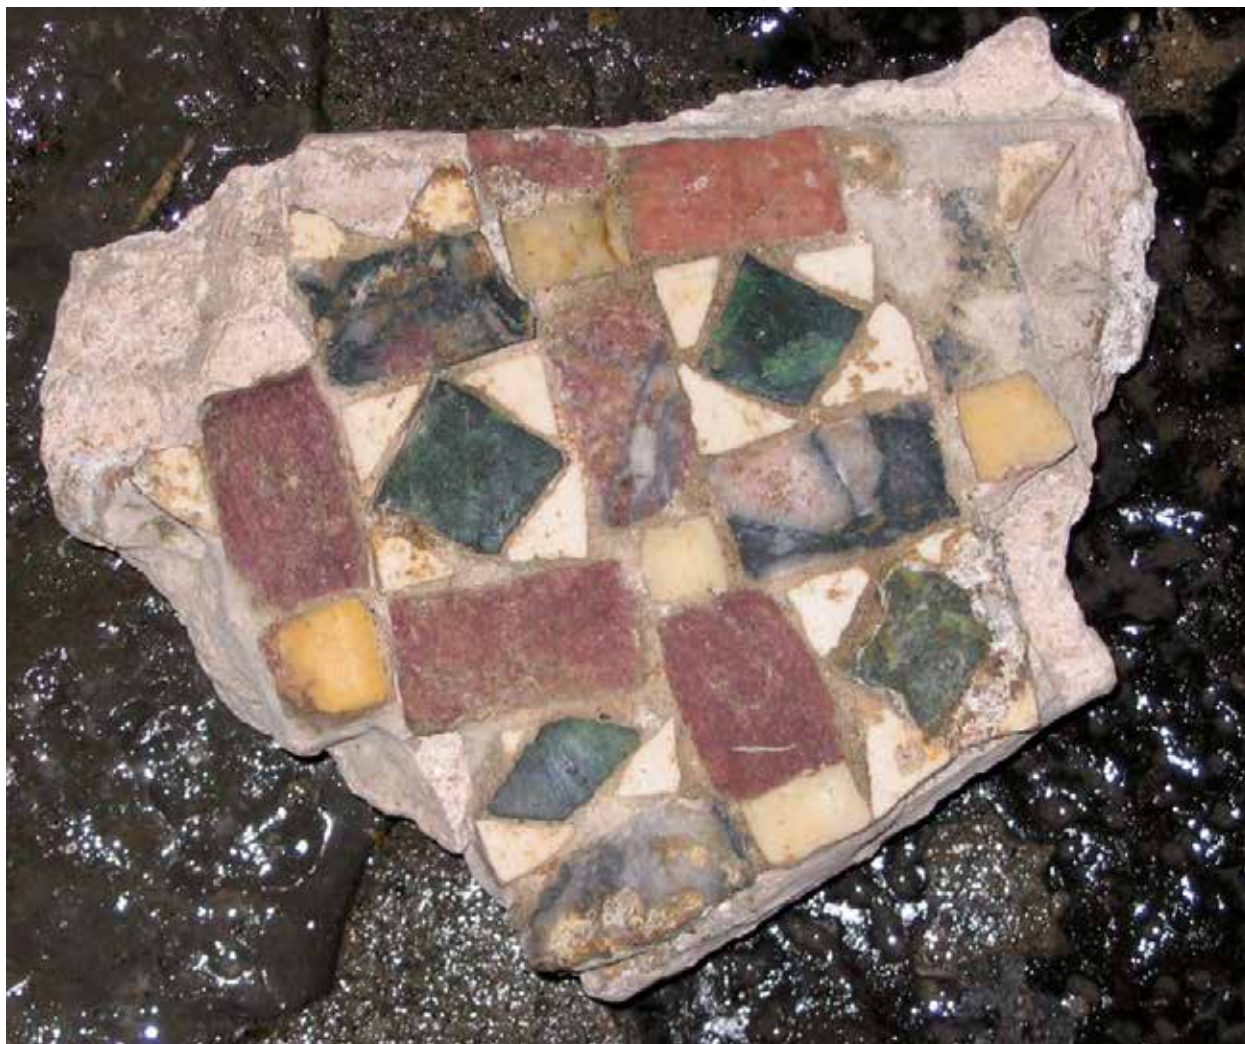
Fig. 41
Medieval mosaic
intarsia found during the
archaeological survey
in the lower Crypt near
the ladder linking to the
Main Church.

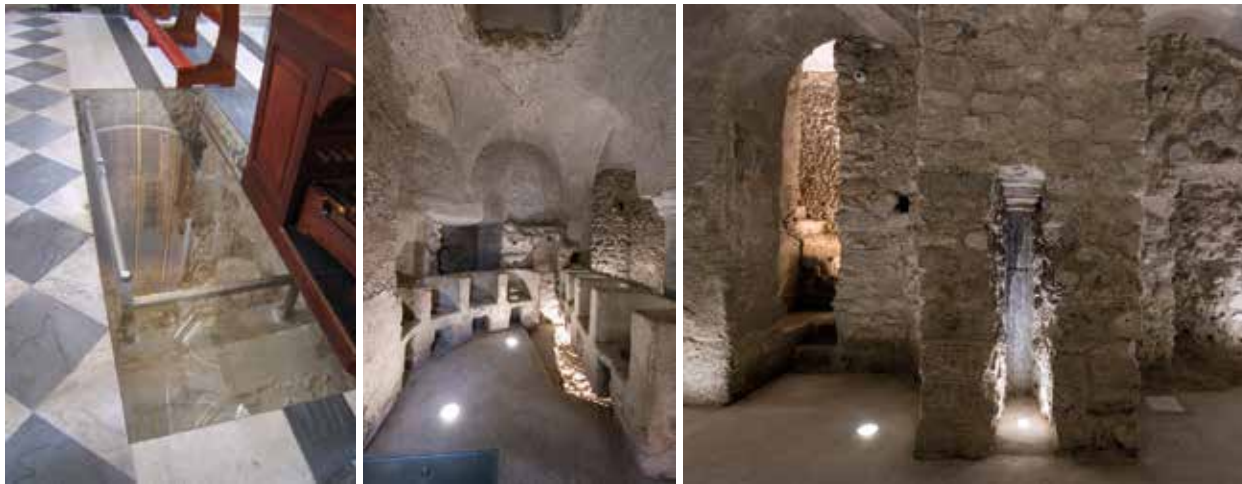
Fig.42
Current floor closing hatch of the staircase leading to the lower crypt from Chiesa di Santa Maria Assunta. It is made of tempered glass and a stainless steel structure and characterised by a lime screed with colourful mosaic tesserae and it is completely independent from the perimeter masonry.

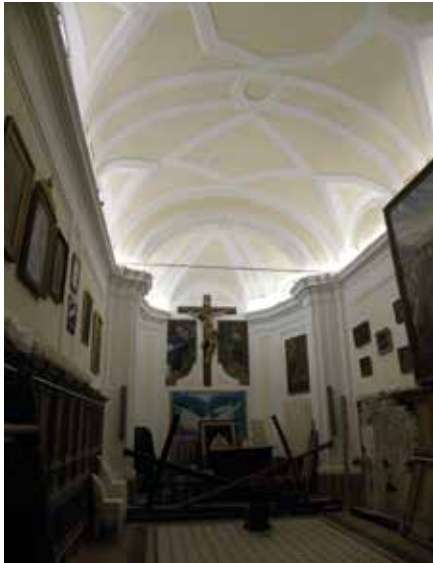
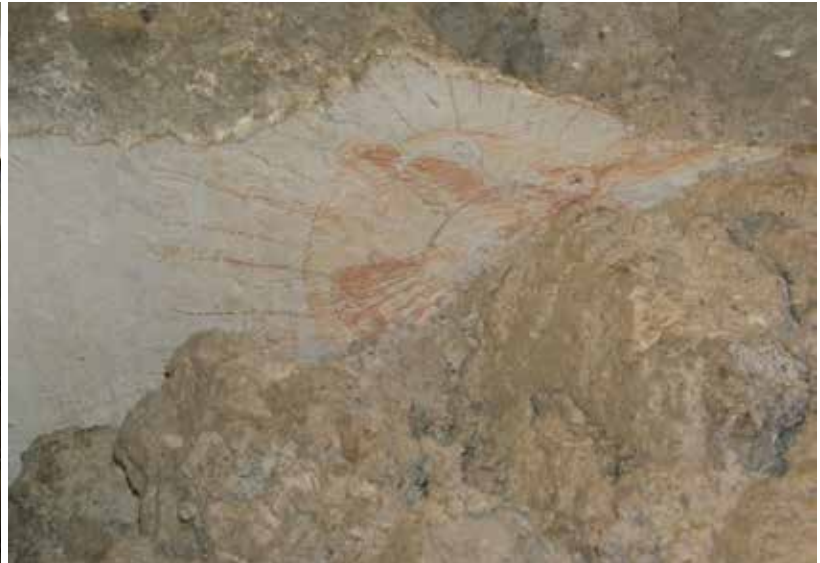
Figs. 52-53
Graphic detail on the original doorway located on the south side of the architectural structure of the Oratory Church.
